# Evaluation of Lime Mortar and Conservation Techniques in Traditional Elements

Kamyar Kamyab<sup>1</sup>, Adil K. Al-Tamimi<sup>2</sup>, Ghanim A. Kashwani<sup>3</sup>

Directorate of Heritage-Sharjah<sup>1</sup>, American University of Sharjah<sup>2</sup>, Directorate of Antiquities- Sharjah<sup>3</sup>

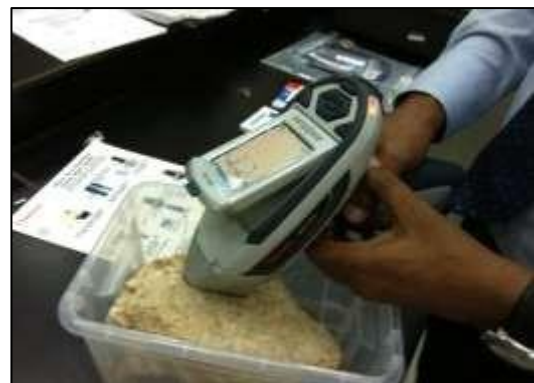
Fig.2

At this test we use portable XRF equipment which is similar to the fixed one, but is easier to work.

Figure 2: XRF (Portable)

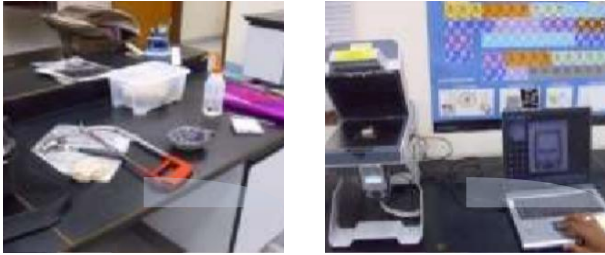
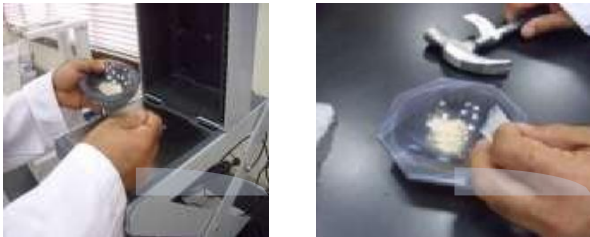
- Sampling: Fig 3

To use these devices, it is necessary to prepare the sample in the right way. There are several steps should be followed to prepare the sample. These steps are:

1. Cutting the sample to a size that we need, about 40mm\*40mm\*40mm. (SEM&XRF)

2. Polishing the sample in coating machine (SEM)
3. Crushing the sample to have a very fine mass of powder. (XRF)
4. Put the crushed sample on the chamber. (SEM&XRF)
5. Conducted the experiment. (SEM&XRF)

**Figure 3:** XRF & SEM sampling

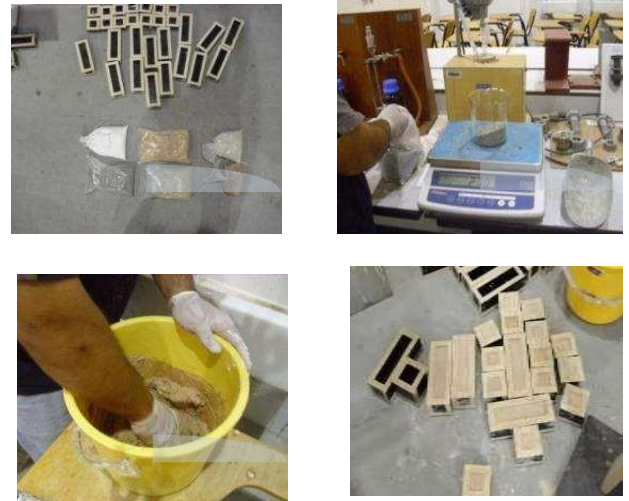
- Preparing new mortar sample: Fig.4

two different sizes of molds were made:

- i. 40mm x 40mm x 40 mm
- ii. 40mm x 40 mm x 160 mm

- Next:
1. Material were prepared.
  2. Material balance and weighted
  3. Material were mixed by hand properly.
  4. The material casted in the molds and have been left for months to be ready

**Figure 4:** Steps to use to produce the new mortar

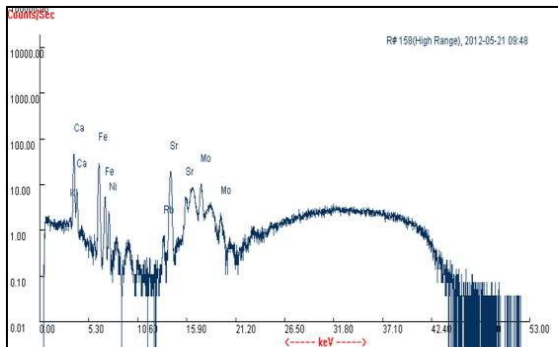
Figure 8: XRF plot of the New Mortar

The new mortar was almost a good match comparing with the all old mortars where it contains all the common elements that mentioned before. The similarity was not only in the existence of the elements, but also with the quantity and the distribution of them. For example the amount of the Ca in the new mortar is 238349.125 ppm and the average of the Ca in all the old mortar samples are 200566.25 ppm. This applied with all the other major elements which mentioned before. This indicates the good possibility that the new mortar could behave in the same way of old mortars. From this indication the aim of this search journal could be achievable (using the new mortar in Sharjah restoration projects).

It should be notice that there are elements are shown in the graphs that are not in existed in the samples such as (Ag). The reason behind that is due to the XRF device where it contains some metals which cannot be noticeable in the graph. However, during the analysis, the XRF will not

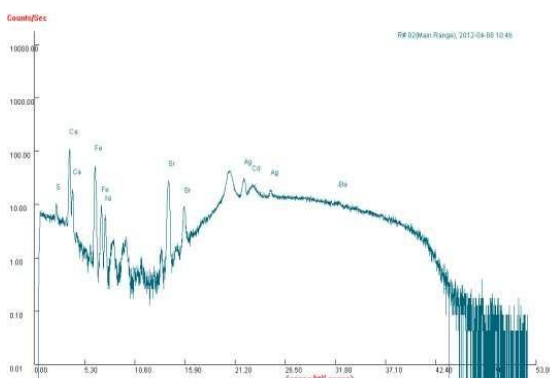
Figure 9: XRF plot of the Khour Kalba Plaster

It is noticeable that all of the samples have a same fundamental elements such as Ca, Fe, Sr, Sc, and etc; but the percentage is different. For example, for all the old samples, (Ca) has around 30-40% of the whole sample. Also (K) and (S) together can present more than 10 % of the sample size.

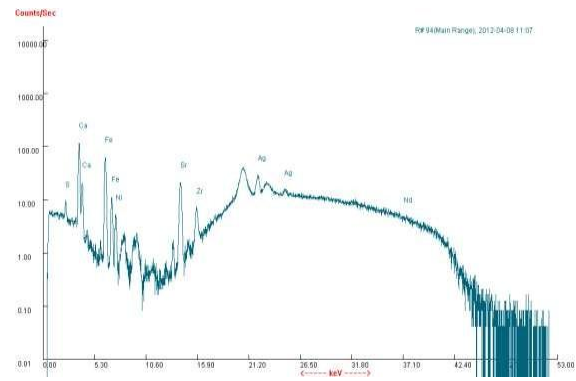
Figure 10: XRF plot of Sharjah area

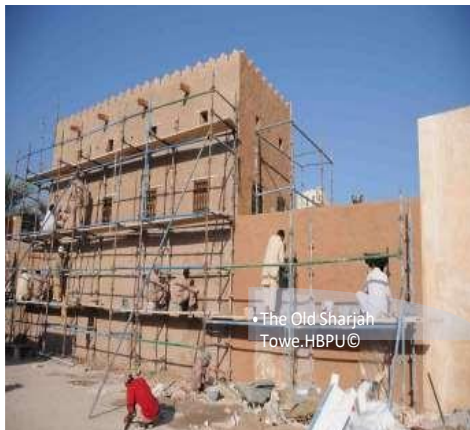
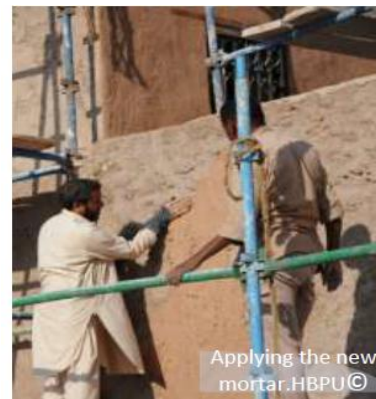
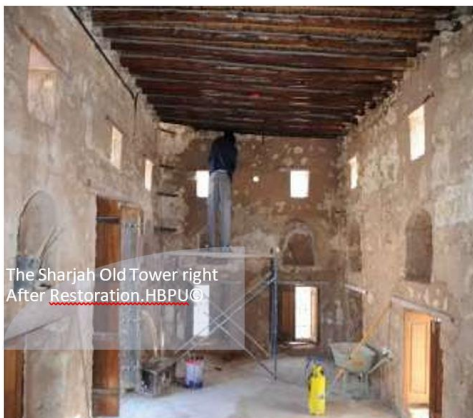
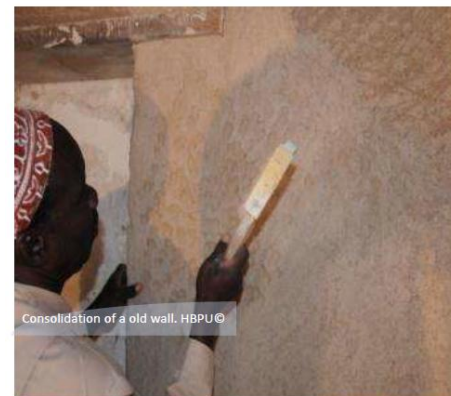
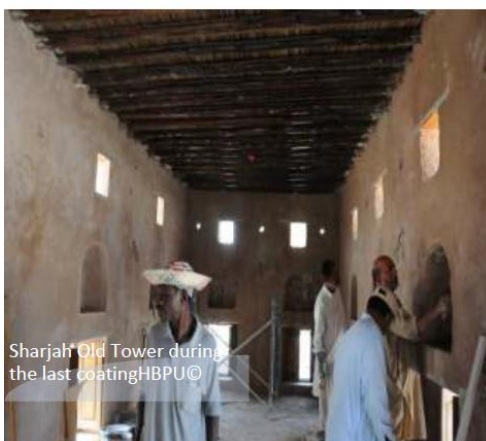
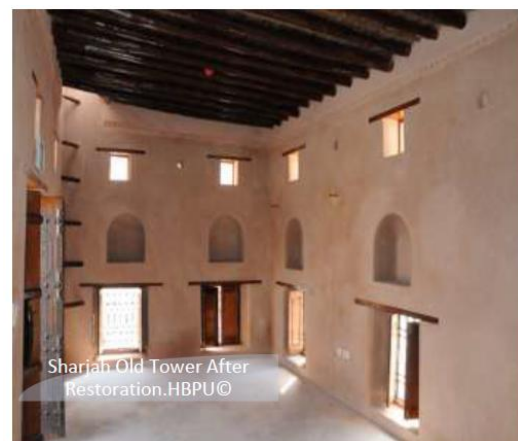
Figure 9: pictures of applying some of the new mortar in some Sharjah restoration projects
